Tech Help

Applications: All Subaru vehicles

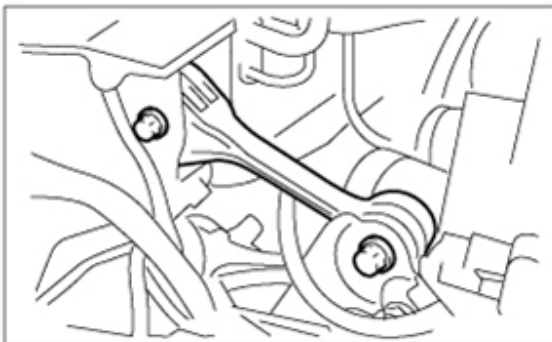
Figure 1

It is very important to check **motor mounts** on any vehicle prior to replacing a CV Axle. If a motor mount is worn or broken it may cause excessive engine movement that could result in the axle exceeding its plunge distance and pulling out of the transmission. Subaru axles are designed to operate at a greater angle of declination than most vehicles. In addition to a possible separation with the transmission these axles may create a vibration or noise if they continue to operate at the maximum plunge distance. Worn or broken motor mounts may cause this action. In addition Subaru have a third mount referred to as the Transmission mount (see Fig. 2). If the rubber in the cradle is worn or cracked it may also contribute to excessive engine pitch. The engine pitching stopper (see Fig. 1) also has two rubber isolators that need to be checked for wear, stiffness or cracking. On some models of Subaru a heat shield and exhaust pipes may interfere with checking these components.
