# Tech Help

**Applications:** All 2001 and newer Volvo 60, 70, and 80 Series

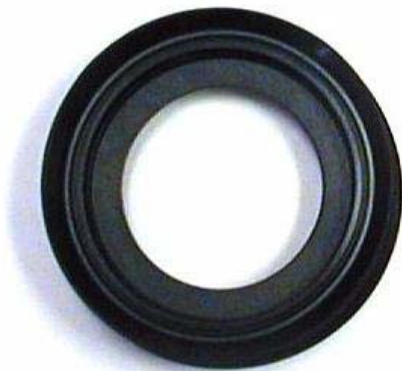
Front View - Faces Hub

When shifting from Drive into Reverse or from Reverse into Drive, a pinging type noise may be heard. This noise may also be heard when cruising and/or during acceleration or deceleration. This is not a manufacturing defect in the axle. A sealing washer (see picture below), is needed to resolve this issue (refer to Volvo TSB #77-08).
