# Tech Help

**Applications:** Ford Probe, Contour/Mystique, Cougar  
Mazda 626, 6, MX-3, MX-6

**GSP Part Numbers:** NCV11533, NCV11539, NCV11541, NCV11543, NCV11995,  
NCV11998, NCV1360, NCV47003, NCV47501, NCV47505,  
NCV47509, NCV47520, NCV47533, NCV47541, NCV47567,  
NCV47569, NCV47580, NCV47582

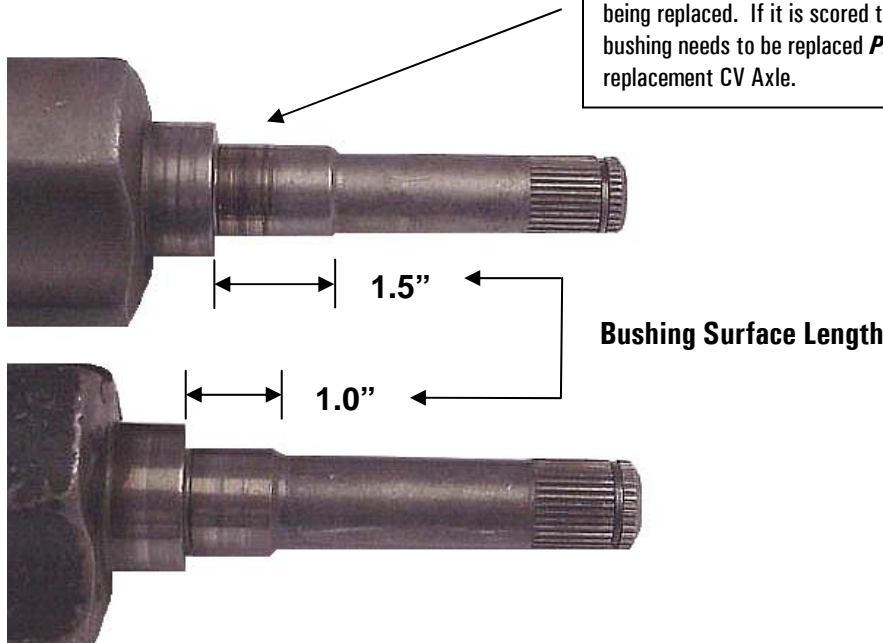
### Example of Surface Scoring

For the above listed applications the transmission support bushing is failing. If the bushing is not repaired **prior to installation** of the GSP CV axle, it will result in the failure of the inboard joint. Failure in this area is not the fault of the axle. The transmission bushing wears and consequently wears out the surface of the inboard housing. There are two bushing surface lengths on the inboard housing: 1" and 1.5". Both styles will work for replacement. The illustration below notes the bushing surface length difference and an example of the surface scoring. Another indication that the transmission bushing has failed is if there is metal transfer on the axle when it is removed.

Be aware that if there is scoring on the surface of the axle when removed or any metal transfer, the transmission bushing should be replaced before installation of the replacement CV axle. If the bushing is not replaced, it is likely that the transmission will leak and a vibration or knocking noise will be present. The most common causes of these bushing failures are worn front struts and/or a bad thrust angle alignment and/or worn motor/transaxle mounts.

**WARNING** – Check this bushing surface on the unit being replaced. If it is scored the transmission bushing needs to be replaced **PRIOR** to installing the replacement CV Axle.
